Valhall DP P&A project: “The Project that has it all”

Valhall P&A Team
BP Norway

Stavanger, September 2016

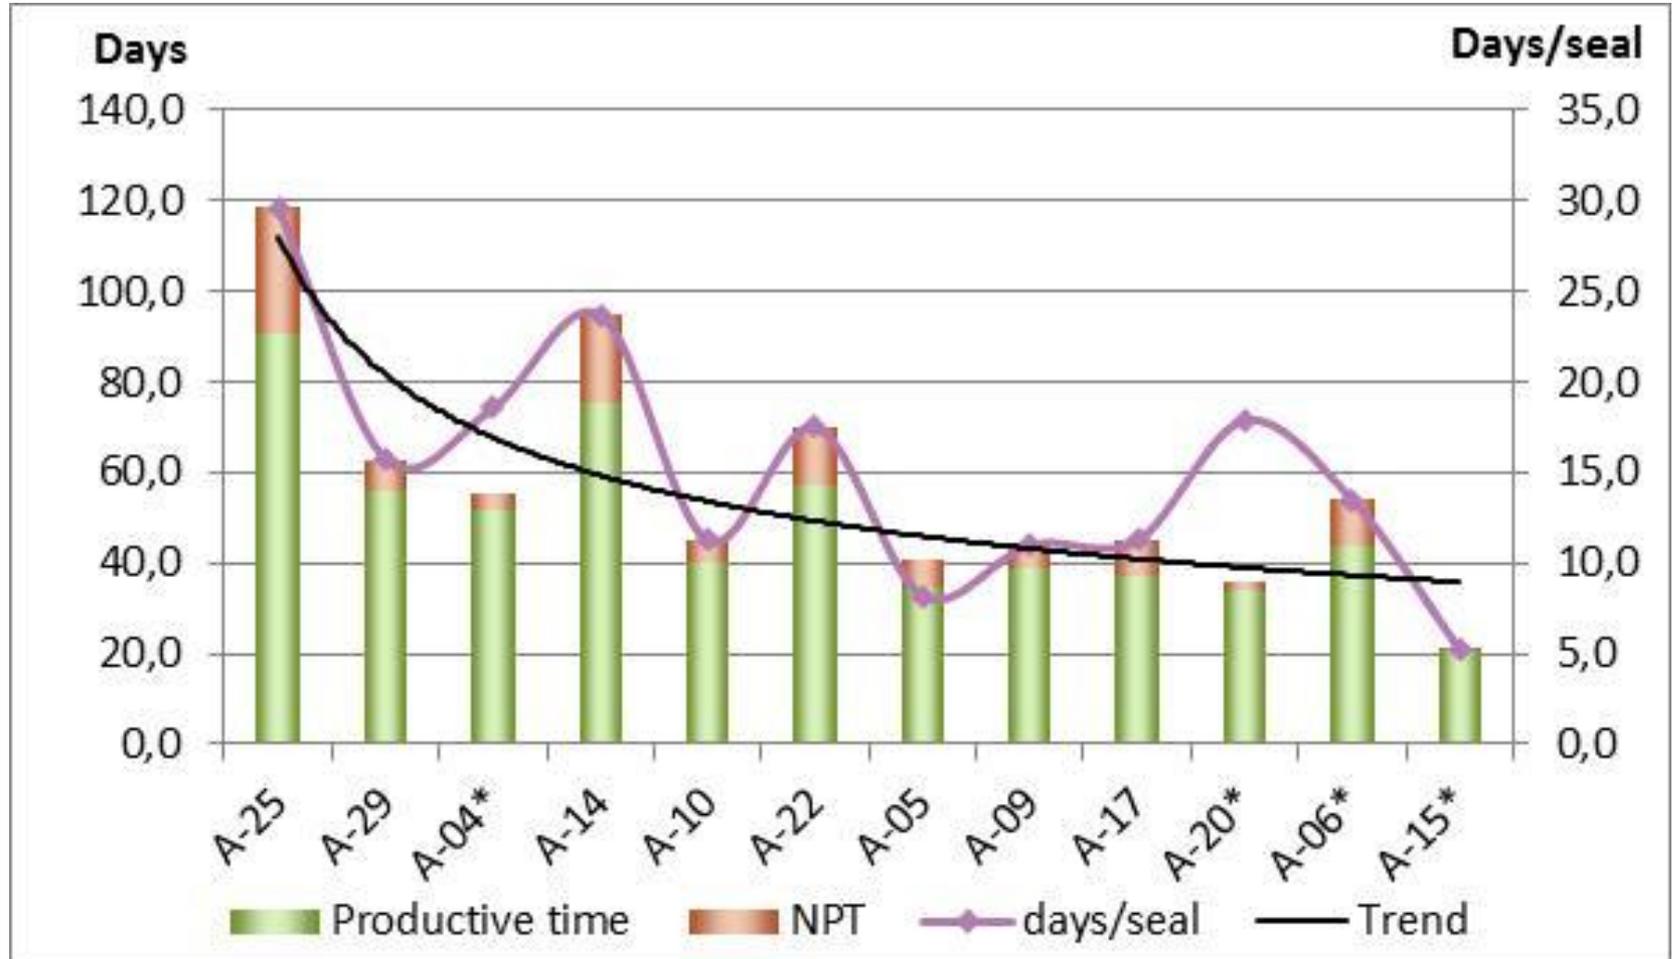
What we have delivered so far

Worked 16 156 hrs with 2 623hrs Non Productive Time – i.e. 14,4%

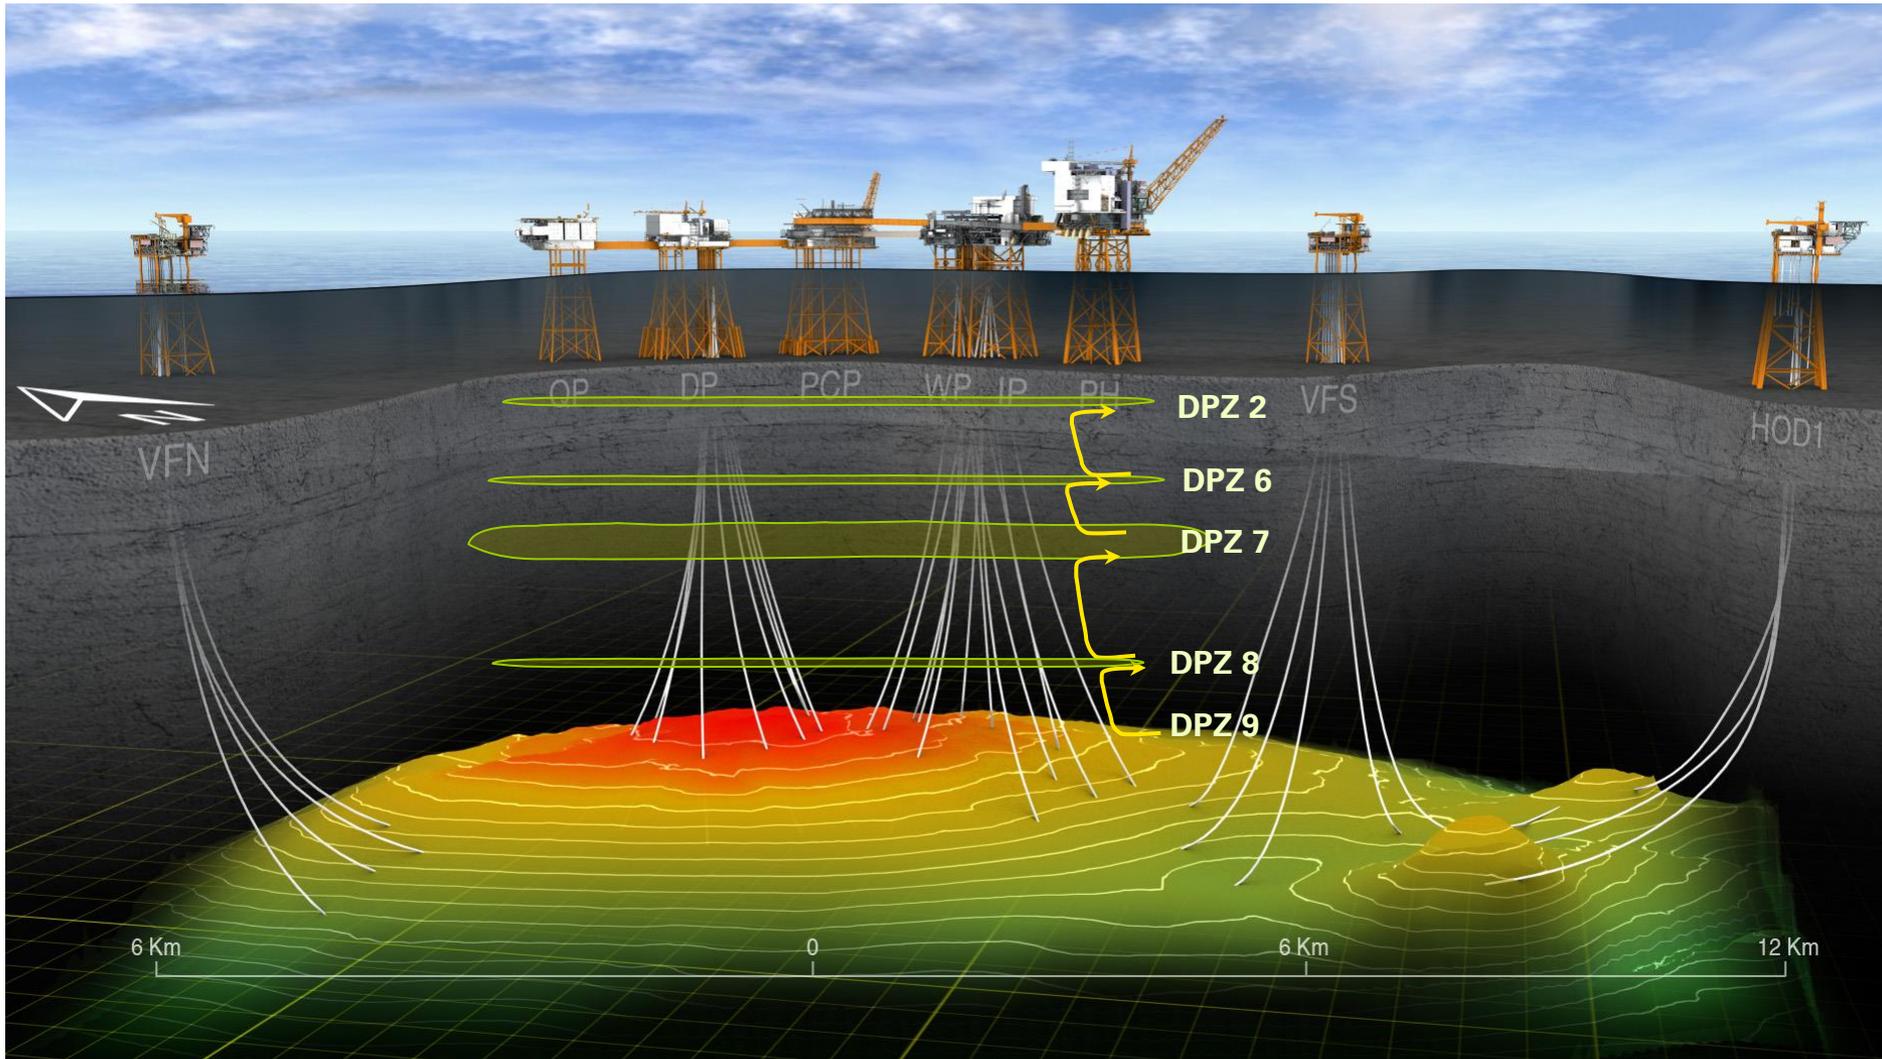
Strategy for Valhall DPZ zonal isolation

- Kill A-annulus
- Recover tubing
- Clean out and log 9-5/8" casing
- Restore seal 9, 8, and 7 (PWC)
 - Kill B-annulus
 - Remove C-section
 - Recover 9-5/8" casing
 - Clean out and log 13-3/8"
 - Restore seal 6
 - Kill C-annulus
 - Remove B-section
 - Recover 13-3/8"
 - Clean out and log 20"
 - Restore seal 2
- Install surface barrier

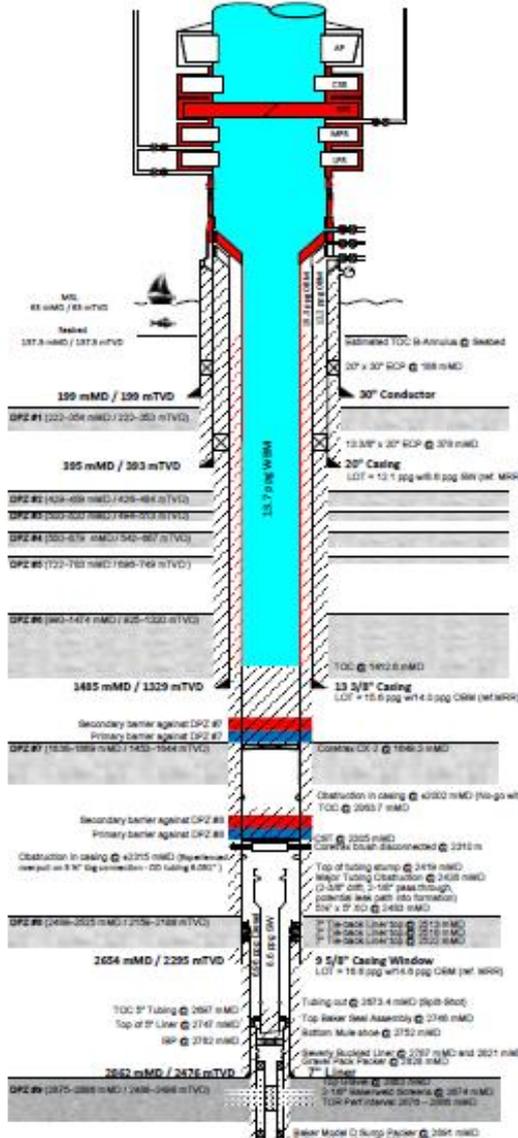
Daily Well Status – Communication Tool

VERIFICATION OF BARRIERS SEAL 8					
Date	Operation	Top	Blm	Mud	Comment
28.06.16	SBT logging for annular barriers outside 9 5/8" csg	1869 mMD 1643.2 mTVD	2295.4 mMD 1996.8 mTVD	WBM 14.2 ppg	SBT log showed 426.4 mMD / 353.6 mTVD of circumferential bonding within Seal 8.
29.06.16	Internal cement plug inside 9 5/8" casing	2063.7mMD 1804.3 mTVD	2305 mMD 2004.8 mTVD	WBM 14.2 ppg	Length of plug: 241.3 mMD / 200.5 mTVD. Load tested to 16 kibs (29.06.16). Pressure tested to 300/1000 psi for 5/30 min. CST installed as foundation.

VERIFICATION OF BARRIERS SEAL 7					
Date	Operation	Top	Blm	Mud	Comment
28.06.16	SBT logging for annular barriers outside 9 5/8" csg	1485mMD 1328.4 mTVD	1636 mMD 1452.4 mTVD	WBM 14.2 ppg	SBT log showed 151 mMD / 124 mTVD of circumferential bonding within Seal 7.
30.06.16	Conetrac CX-2 plug installed in 9 5/8" csg	1649.3mMD 1463.3 mTVD	1650.2 mMD 1464 mTVD	WBM 14.2 ppg	Tagged with 8 kibs (30.06.16). Pressure tested to 300/1000 for 5/30min (30.06.16)
30.06.16	Internal cement plug inside 9 5/8" casing	1412.6mMD 1268.9 mTVD	1649.3 mMD 1463.3 mTVD	WBM 14.2 ppg	Length of plug: 236.7 mMD / 194.4 mTVD. Load tested to 20.6 kibs (01.07.16).

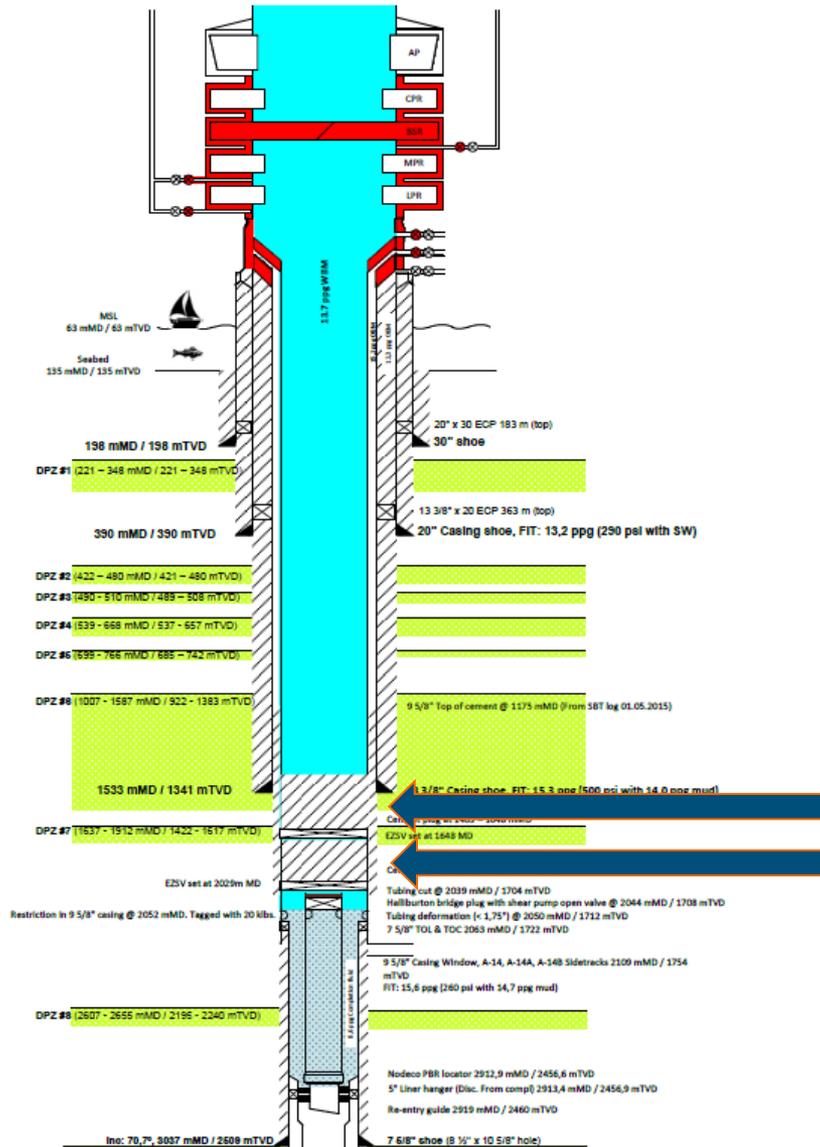
Daily Well Status – Communication Tool Shale and PWC

Perf, Wash & Cement barrier
Shale barrier externally, cement internally
